ARCHAEOLOGICAL EVALUATION

Report	Evaluation Report
Project	Upper English Street, Armagh
Planning Ref	LA08/2019/0154/F
Licence No	AE/21/124
Grid Ref	281638, 438559
Date	23/09/2021

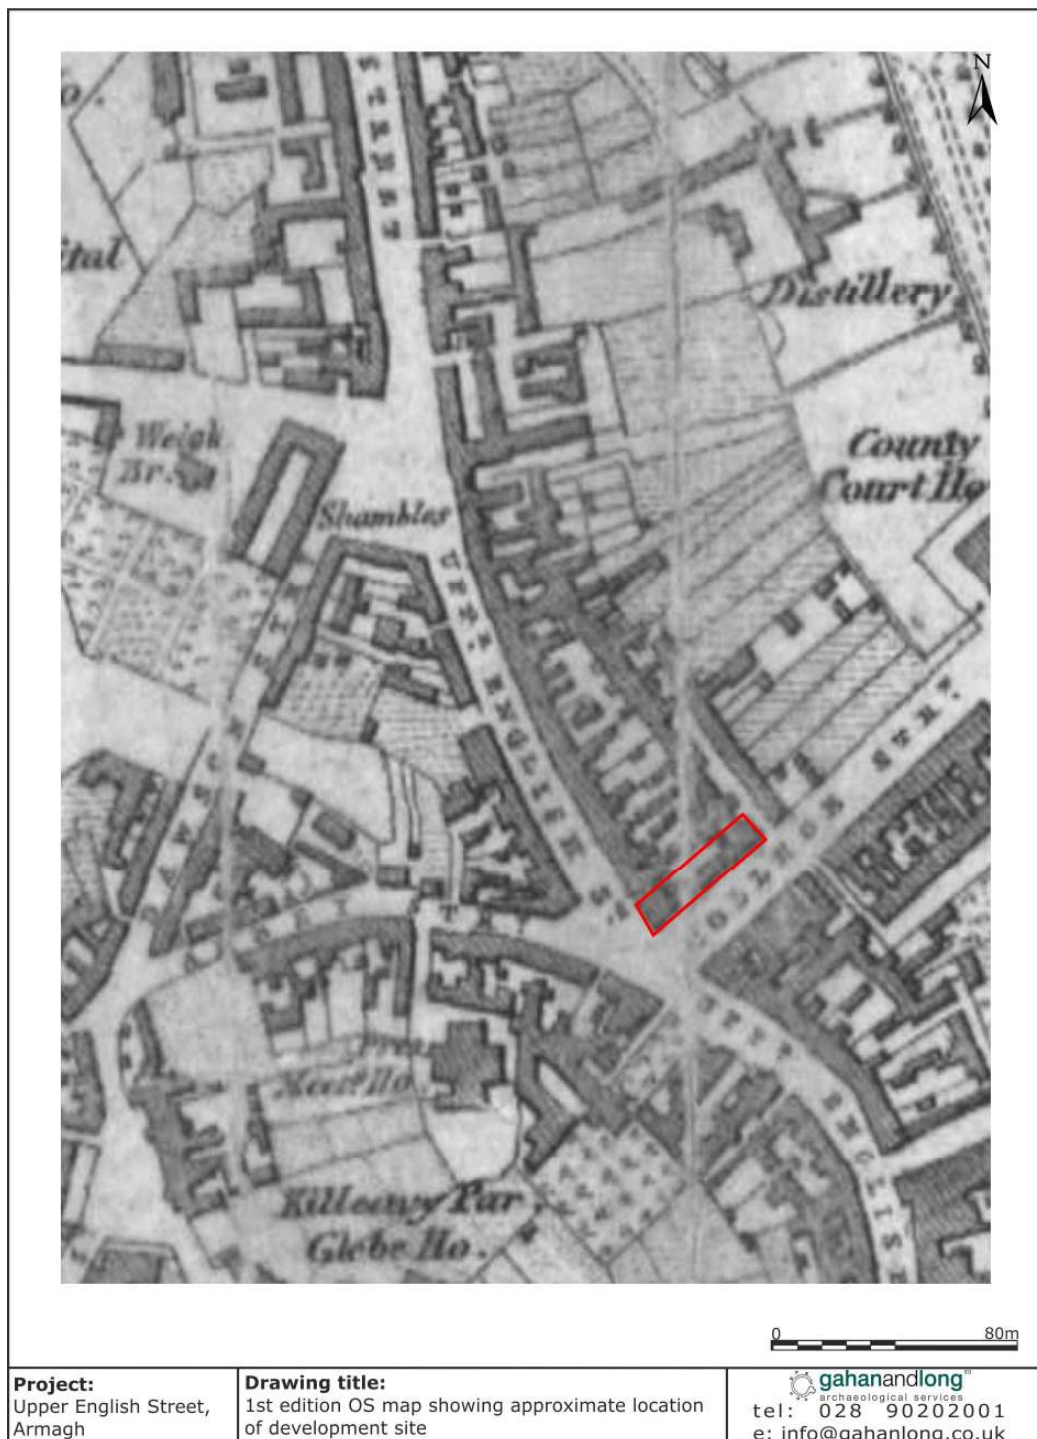
Figure 3: 1st edition OS map showing location of the development site.

The Upper English Street frontage of the site contains a basement relating to earlier properties located here. An inspection of the 1st edition OS map shows the proposed development to contain structures along its Upper English Street and College Street frontages and to the rear of the property (figure 3). These buildings are shown on the available OS maps up to the 4th edition (1905). By the time of the 1:10,000 scale OS map (1957-1986) the Upper English Street frontage has been demolished to ground floor level.

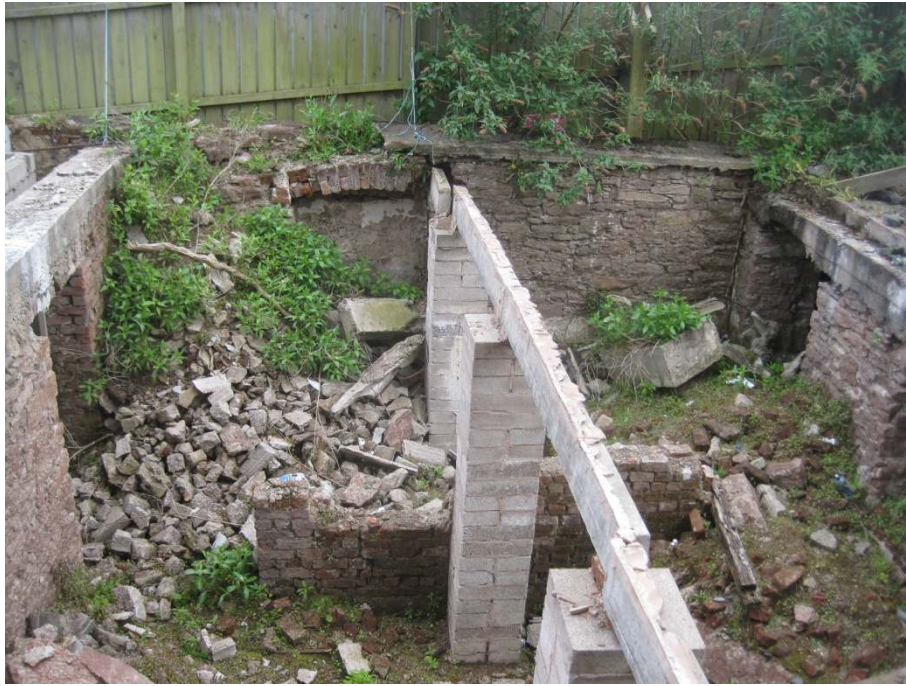
Plate 1: open section of basement area looking south.

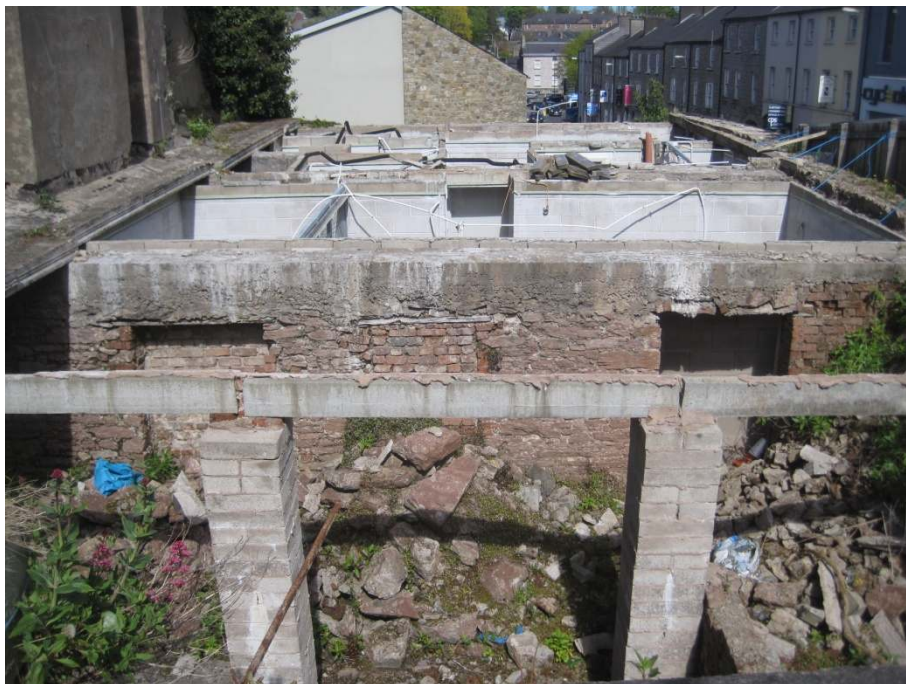
Plate 2: rear wall of basement area showing bricked up openings and modern construction beyond.

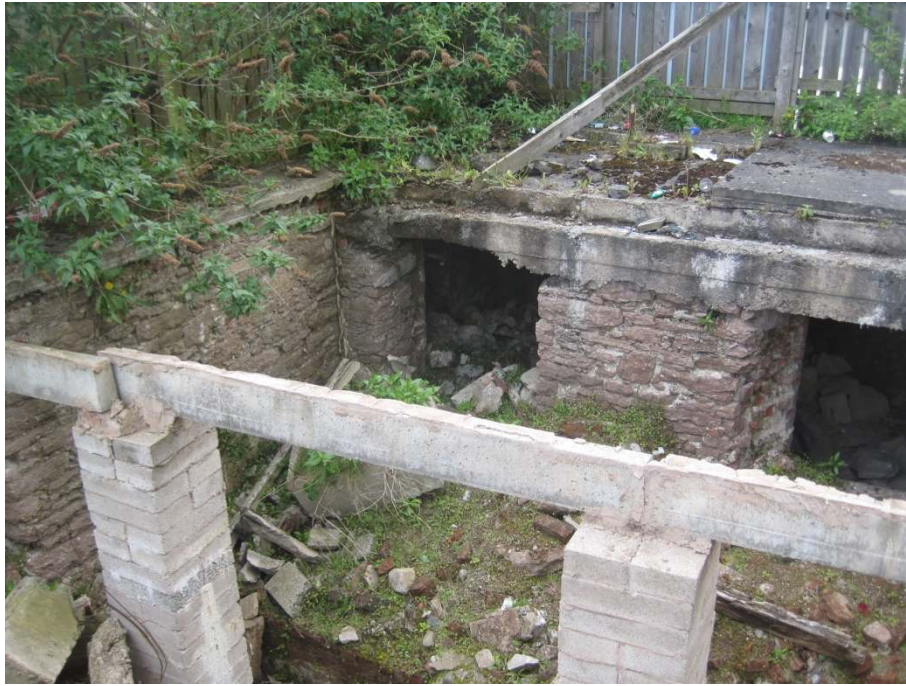
The basement area of the Upper English Street frontage was retained following the historic demolition on the site. At the time of the initial site inspection, it was not possible to enter this part of the site for safety reasons. Inspection of the site from street level revealed it to consist of an open area defined by two stone and brick walls extending across the width of the site (parallel to Upper English Street) and which were in turn divided by a mostly demolished, red brick internal wall, extending perpendicular the street frontage (plate 1). Both the end walls were capped with modern concrete beams/ block work. Two of the openings within the rear wall of the property have been infilled with red brick while the third has been blocked off by the construction of a modern development, constructed under an earlier planning permission (plate 2). The openings of the front wall of the property remain open and lead into surviving basement areas which extend towards Upper English Street (plate 3).

Plate 3: front wall of basement area showing opening into surviving basements.

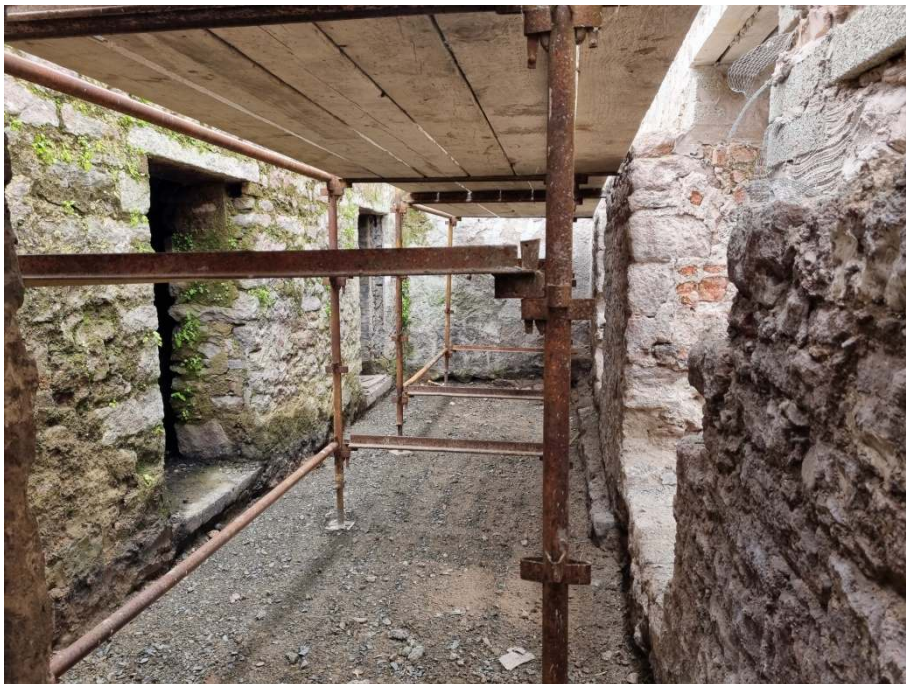
As more complete assessment of the basement area was possible following the demolition of the modern elements and the removal of modern in-fill. As the site continues towards Upper English Street, an additional wall was identified extending across the width of the site. This wall was previously sealed by concrete slabs. It is of the same stone and brick construction and retains three openings matching up with those previously exposed as the frontage of the property (plate 4).

Plate 4: looking north across the Upper English Street frontage of the site.

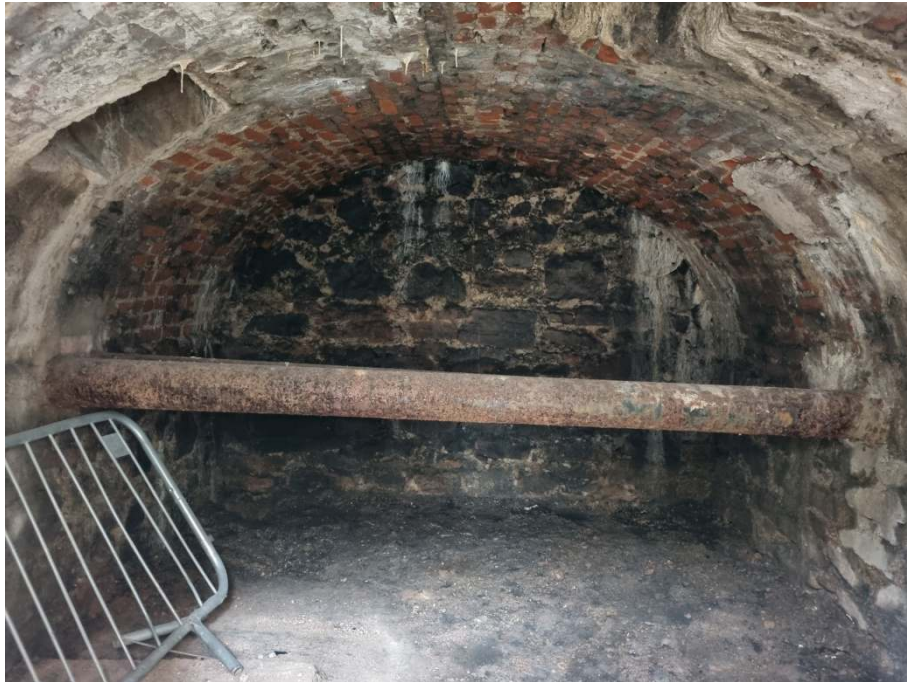
Beyond the frontage wall, the openings lead into three basements which consist of stone walls with arched red brick roofs (plate 5). These small rooms appear to have been utilised as part of the heating system for the former property and elements of this, including piping and spaces for boilers survive (plate 6).

Plate 5: arched basement with heating pipe extending across it.

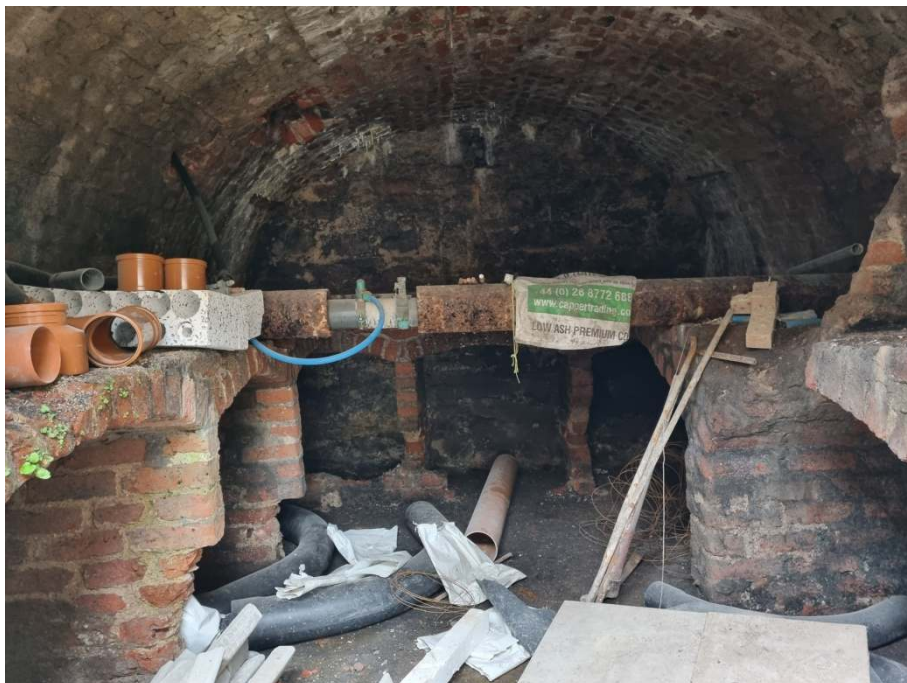
Plate 6: arched basement showing elements of the heating infrastructure.

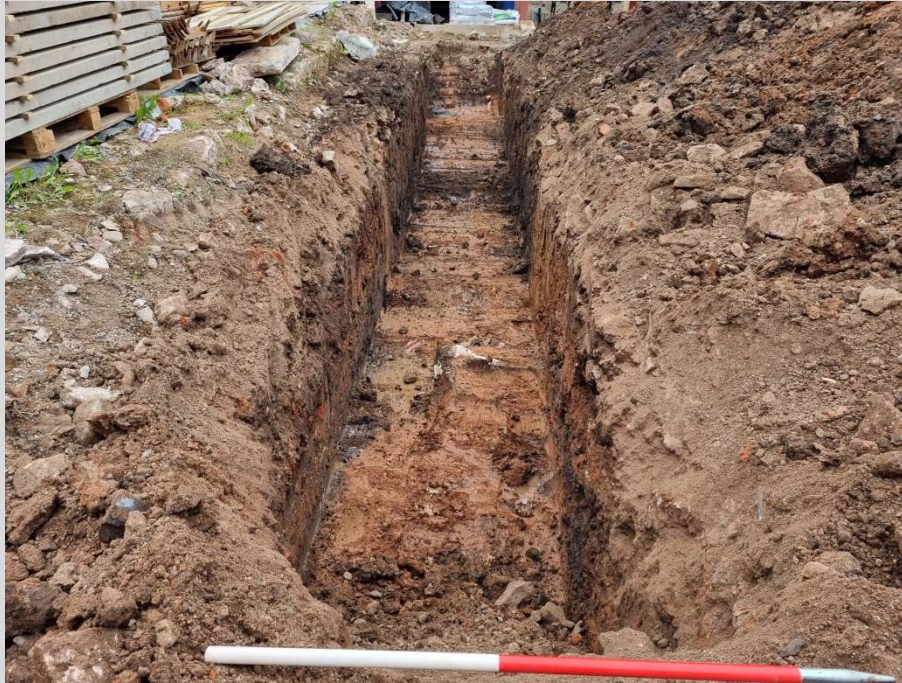
Trench Number	Length	Depth (m)	Archaeology Identified
1	16m	1.2m	No archaeological deposits identified

Trench 1 looking southwest

Surface material was a mid-brown clay/soil, which was in use for storing and was therefore very compacted. This was removed onto a rubble mixture of brick, ceramic pipes, wood etc. Medium to large roots were removed due to trees/bushes. This was removed onto a reddish/pinkish sticky clay subsoil.

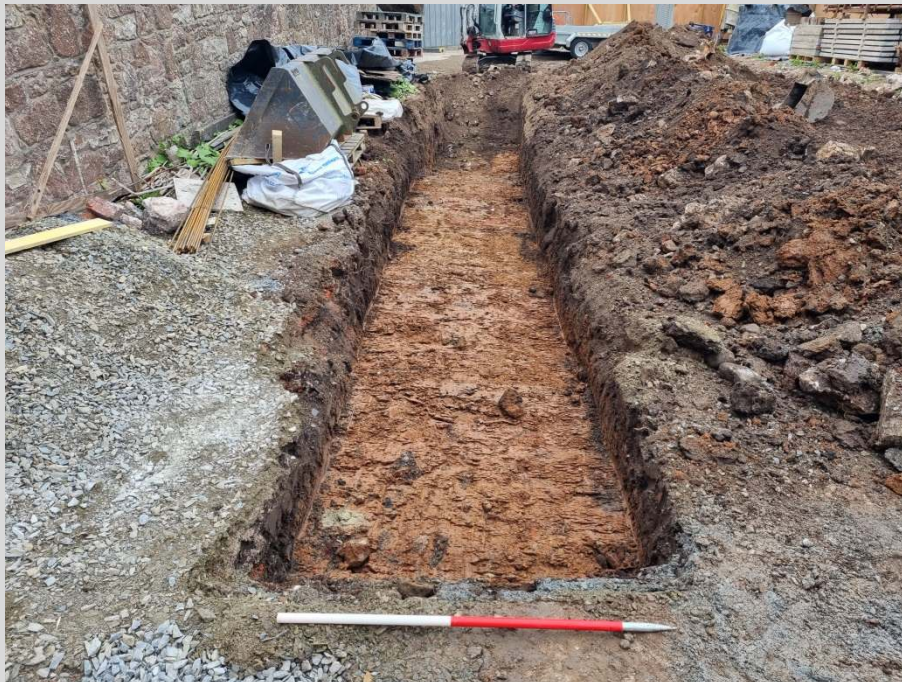
Trench Number	Length	Depth (m)	Archaeology Identified
2	15	0.5 – 1.2m	No archaeological deposits identified

Trench 2 looking northeast

Surface material was a mid-brown clay/soil, which was in use for storing and was therefore very compacted. This was removed onto a rubble mixture of brick, ceramic pipes, wood etc. Medium to large roots were removed due to trees/bushes. This was removed onto a reddish/pinkish sticky clay subsoil.
